## Eurasian Watermilfoil Delineation: Lake John

Spring Delineation Survey – May 11, 2015

Prepared for the Lake John Association (Annandale, MN) – May 2015

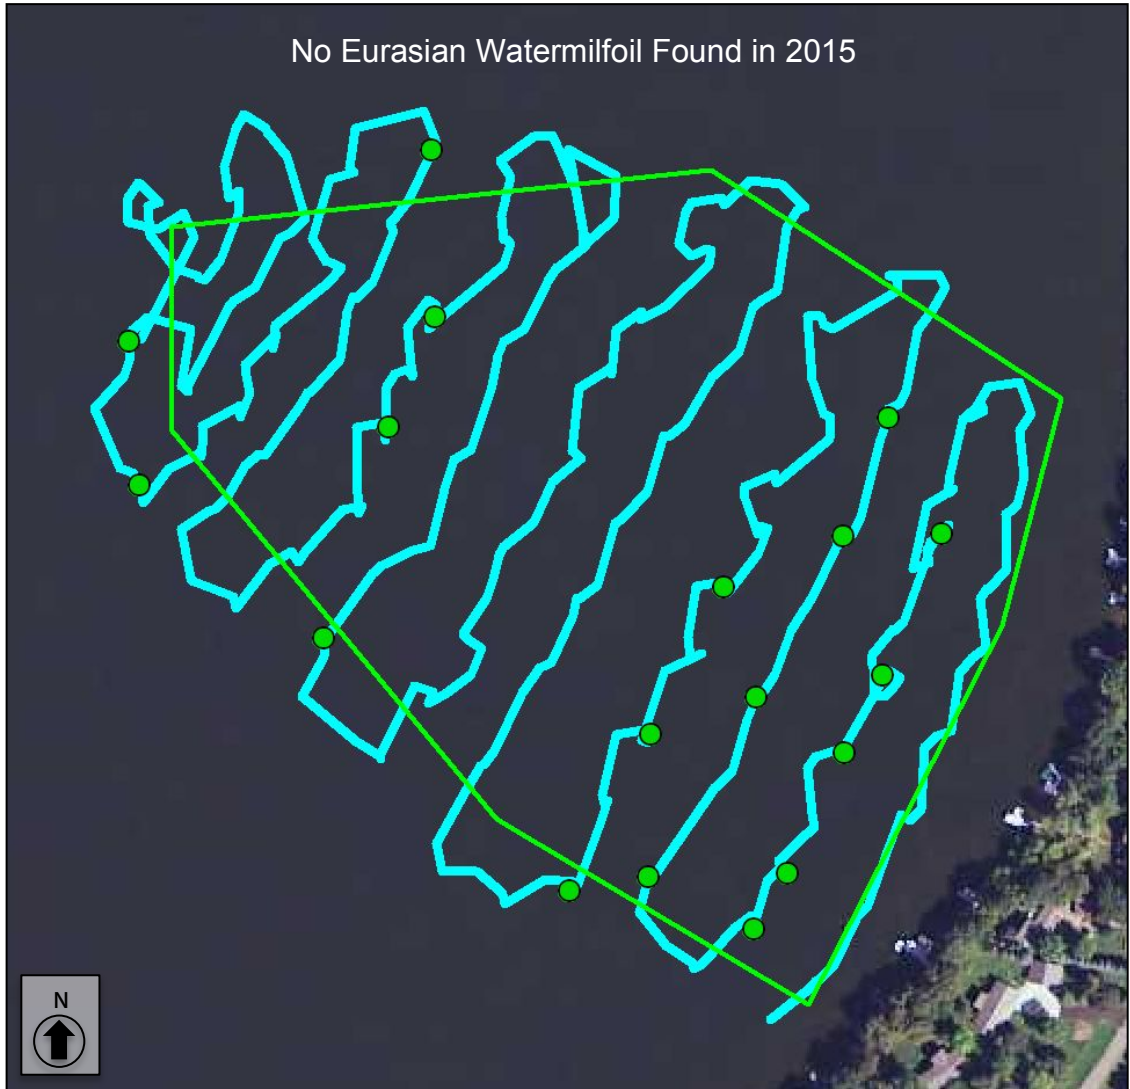
# 2015 Spring Delineation of Eurasian Watermilfoil Lake John (#86-0288-00)

During the May 2015 survey, we found no EWM growing in the surveyed area. In the 2012 delineation survey, we positively identified EWM specimens collected from this area, so the lack of EWM in 2015 indicates that the past treatments in this area have been very effective at controlling EWM. However, in 2015 we did find young shoots of native whorled milfoil (*Myriophyllum verticillatum*) growing at sporadic locations in the surveyed area (see page 3). This native whorled milfoil typically has a higher leaflet count (7-17 pairs) than native Northern watermilfoil (*Myriophyllum sibiricum*; 5-9 leaflet pairs), and this higher leaflet count overlaps with the range for Eurasian watermilfoil (*Myriophyllum spicatum*; 12-21 leaflet pairs). Although most of the specimens we collected had fewer than 12 leaflets, we documented additional features to distinguish these sprouts as native whorled milfoil. These features included the existence of winter buds (dense clusters of leaves) at the base of each shoot, J-shaped stems emerging from these winter buds, tight spacing of leaflets along the stems (<1cm apart), and the overall shape of the leaflets (proximal leaflets substantially longer than distal leaflets). We observed all of these features to be present on the collected specimens, and are confident that these shoots are not Eurasian watermilfoil.

**EWM Delineation Survey**

- Designated Survey Area
- Surveyed Path
- Locations with Whorled Milfoil

Surveyed: May 11, 2015  
Method: Visual, Rake, Sonar, Camera  
Surveyor: J.A. Johnson  
Affiliation: Freshwater Scientific Services, LLC

Based upon these findings, we recommend that the surveyed portion of the lake should not be treated in 2015. At this time it appears that past treatments have successfully controlled EWM in this area and that native plants are recolonizing after treatment. In previous studies, such treatments have provided several years of control, but EWM often returns after several years. Consequently, the Lake John Association should consider having the area surveyed periodically (every 2 to 3 years) to document any recolonization by EWM.
